# Antelope Island Fielding Garr Ranch Interpretive and Site Plan

OCTOBER 1997

STATE OF UTAH  
NATURAL RESOURCES  
Division of Parks & Recreation

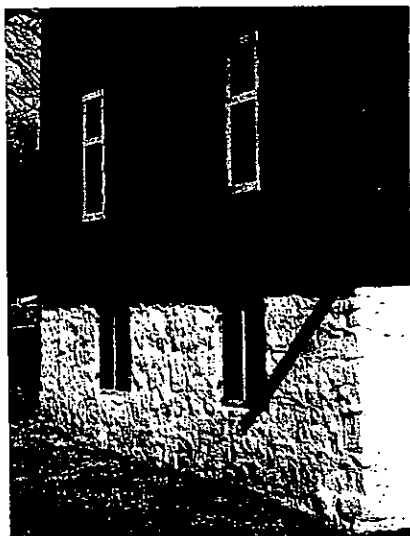
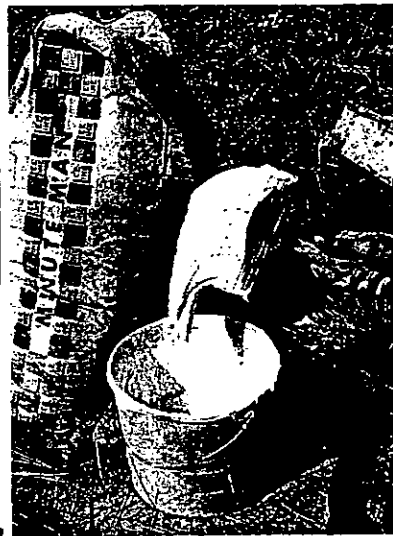
*Whitewash had many historical uses, including painting simple wood buildings, fences, greenhouses, and stonework of all kinds (left). Basically a thin mix of lime and water, whitewash is applied with a wide, fiber-bristle brush (right).*

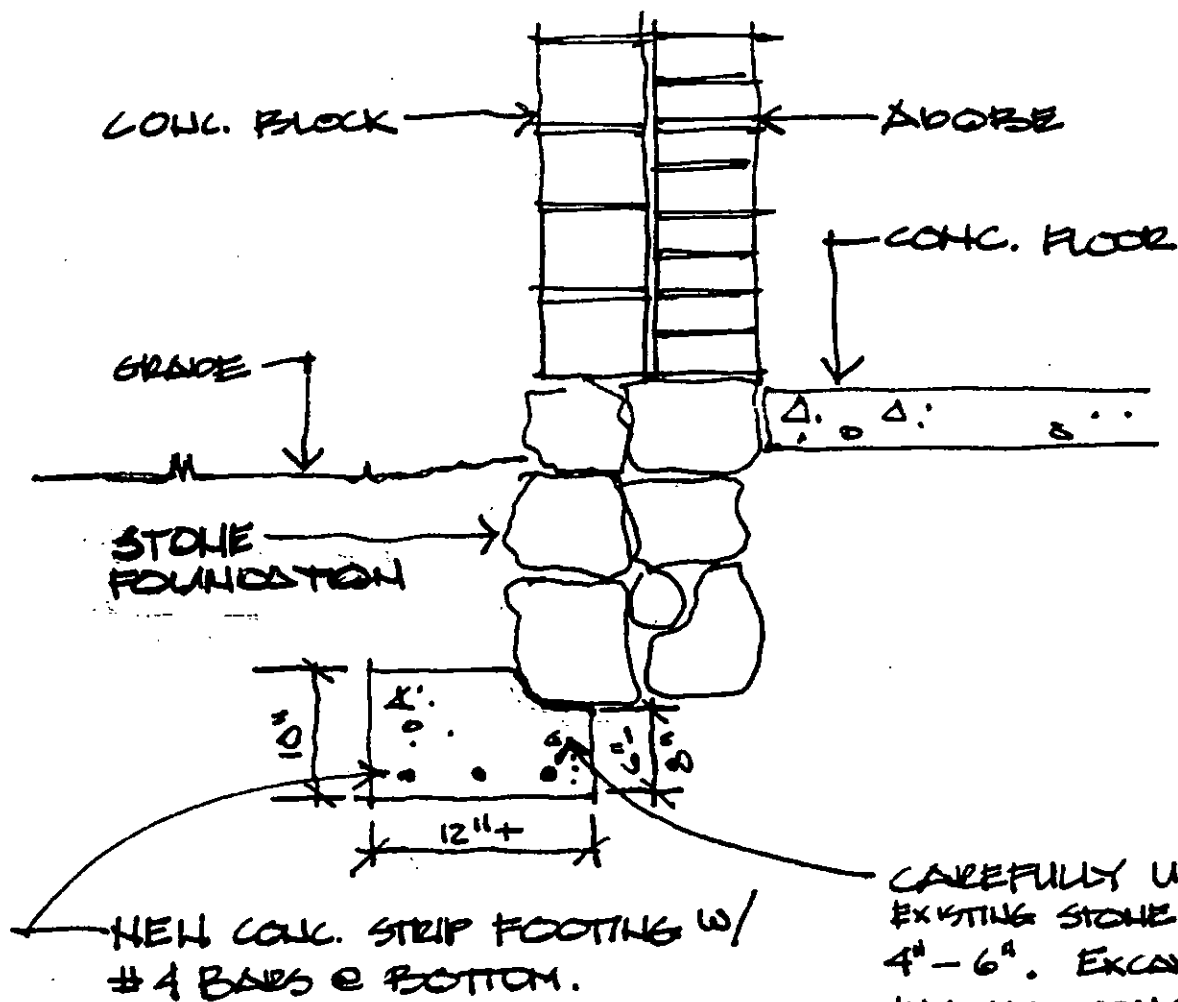
CAREFULLY UNDERCUT  
EXISTING STONE FOUNDATION  
4" - 6". EXCAVATE &  
INSTALL CONCRETE IN  
ALTERNATING 2'-3'  
SECTIONS, IF NECESSARY,  
TO AVOID FOUNDATION  
COLLAPSE.

STRIP FOOTING
